Developing A Standard Workflow for Drone Roof Inspections

Abstract

Keywords: drones, workflow, inspections, roof

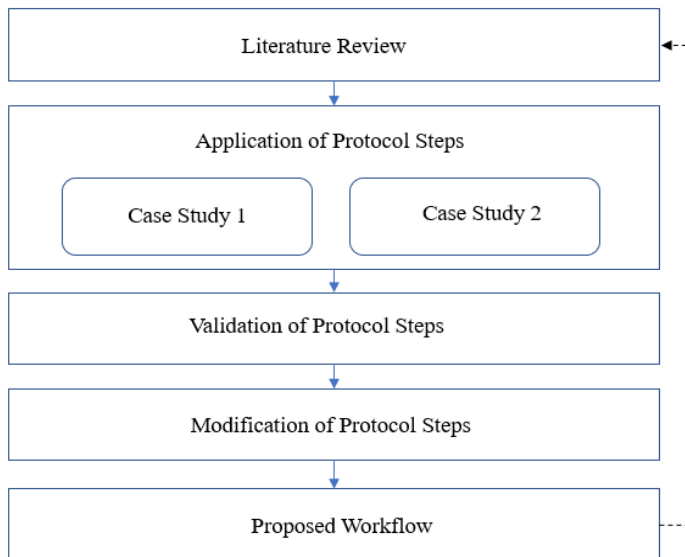
Fig. 1: Research Methodology

As demonstrated in Figure 1, a systematic literature review was conducted to identify previous research on the workflow for drone inspections. A total of eighty-six (86) papers were initially identified based on the abstract of the journal articles. Only peer published articles were selected for the review and literature from thesis, books, online articles and non-peer reviewed articles

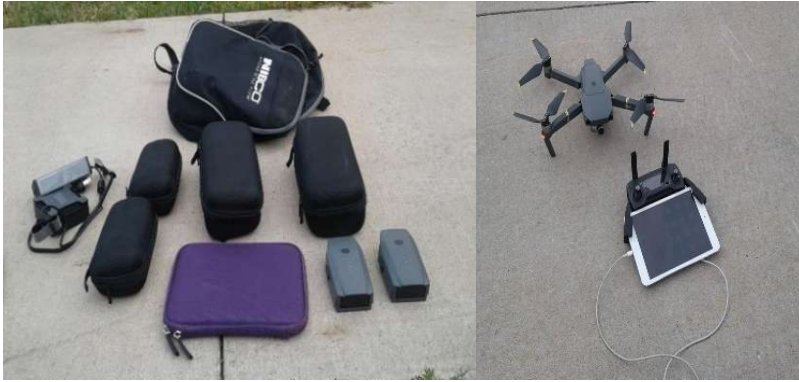
Fig.2: Drone kit for roofing inspection

Based off of the literature review, the above steps were used to conduct roof inspections at the Nauvoo and Independence sites. This was done as a preliminary test to practice following the compilation of protocols listed from existing literature. The DJI Mavic Pro (Fig. 2) was used for this study due to its easy portability, low cost and quick learning speed (72.5 learning hours). For an FM, this model has a reputation for providing appropriate benefit for a nominal investment. As a part of the learning, the operator/pilot was required to obtain the Federal Aviation Administration 107 licensing test for flying in the United States. The total cost of the drone, the accessory and the fees come to about \$1,510.

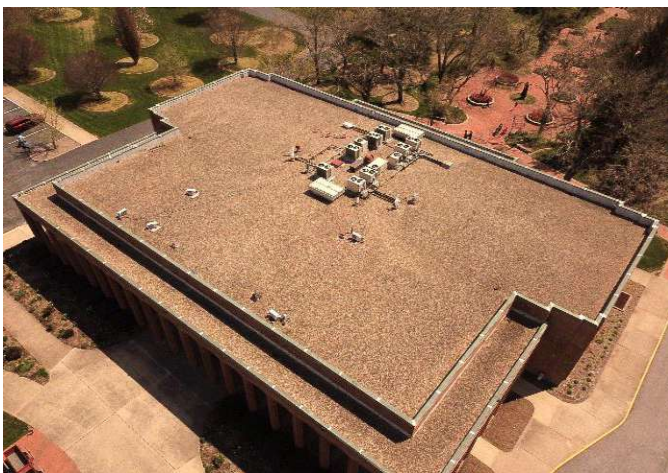
Fig. 3: Case study 1 Nauvoo Visitor Center

Case study 1 was performed at Nauvoo Visitors Centre located in Illinois with a roof area of

9,960 SF, shown in Figure 3. The building has a low-slope ballasted roof. The building was selected from the midwest region of the United States, as it experiences all four seasons of exposure and wear. The varying seasons also impact the roof penetrations and consisted of various mechanical units for heating and cooling the building. Case study 2, shown in Figure 4, was performed at Independence Visitor Center located in Missouri with a roof area of 10,010 SF. The building has a low-slope non-ballasted roof. The building was selected from the midwest region of United States, as it also experiences all four seasons, so as to identify any wear and tear on the roof.

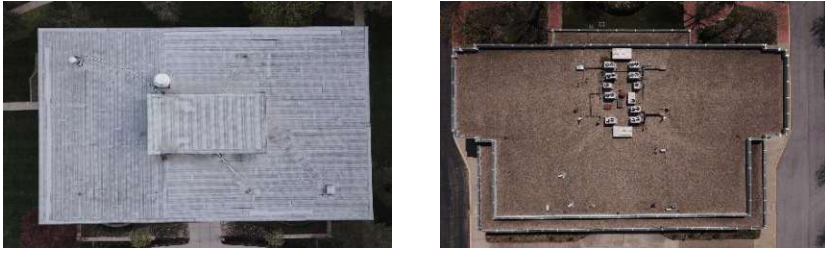
Fig. 5: Examples of Picture Set 2 – Top Views

This view is one taken from approximately 25-60 meters above the roof as the camera points directly downward at a 90-degree angle to the ground. Figure 5 illustrates this view from the two case study structures. It serves to give a single holistic shot of the structure and is followed up with several closer “regional” pictures of the various quadrants of the structure. The closer pictures allow for a more detailed summary of the surface of the roof.

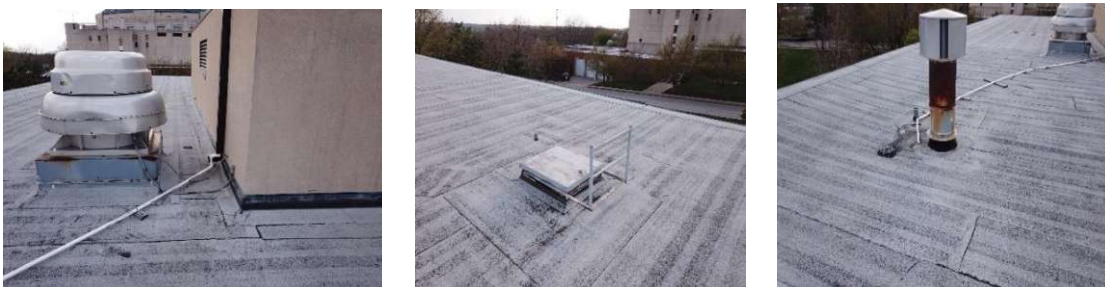
Fig. 6: Examples of Picture Set 3 – Angular Views

This set of pictures takes various high definition “angular photos” of all major penetration points and parapet wall joints to the flat (or pitched) roof. This Picture Set is the most tedious of the data because it includes vent joints, chimneys, antennas, HVAC-related items, parapet walls, etc. Examples of this picture set are found on Figure-set 6, below. Photos are typically taken at about 5-20 feet from penetrations and from 2-4 sides. Occasionally there are environmental items, such as trees, power poles, and miscellaneous cables that make it difficult to get optimal views. However, the overlap of pictures over the areas should cover the necessary surfaces sufficiently.

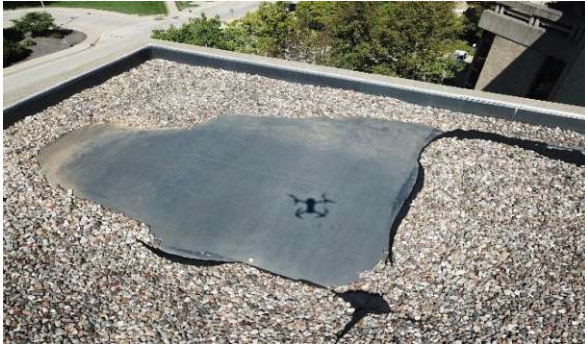
Fig. 7: Picture Set 4 – Problem area examples

This picture set is initially directed by the owner’s instructions. Special areas such as any roof damage, water ponding, window close ups, nests from animals or insects, mortar joint conditions or gutter conditions are typically requested areas. Figure 7 shows an example of an area where either damage or unfinished repairs have been undertaken. The pilot is also commissioned to document any unforeseen damaged or abnormal areas that are found during the flight inspection.

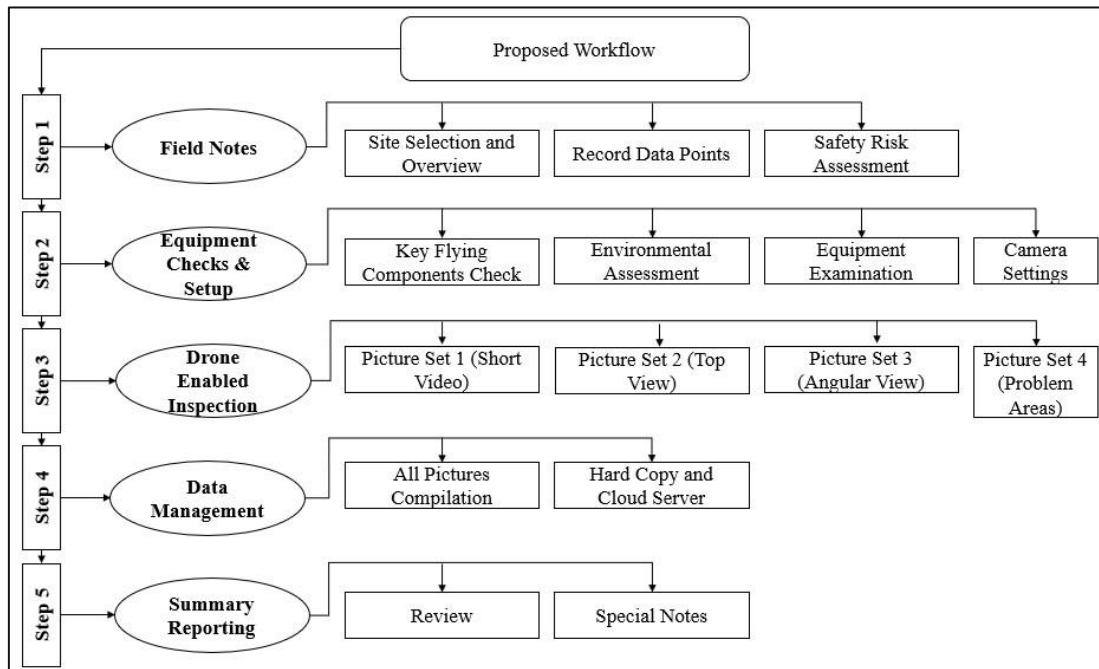
Fig. 9: Proposed 5-step workflow for drone roof inspections

The final summary, step 5, includes a review of the entire process with highlighted special notes of areas of focus. This report can be done on paper, presentation or via video conference. A finalized workflow diagram of this process is shown below in Figure 9.
